Manhole Inspection Summary

Manhole # S41CC_048MH

Insp Date: **12/13/07 11:05 AM**

Location Address: **chuch sq shopping cntr**

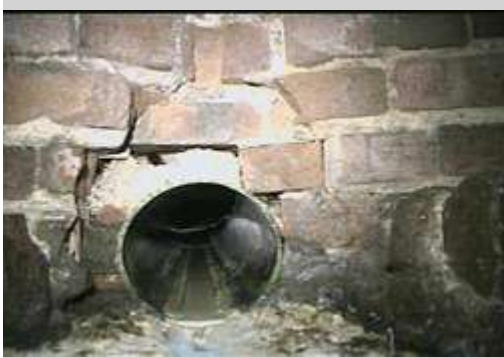
Defect 2

Condition: ☐ Sound ☒ **Cracked** ☐ Root Intrusion ☒ **Loose Brick** ☒ **Deteriorated**

barrel wall cracked, deteriorated, & loose brick

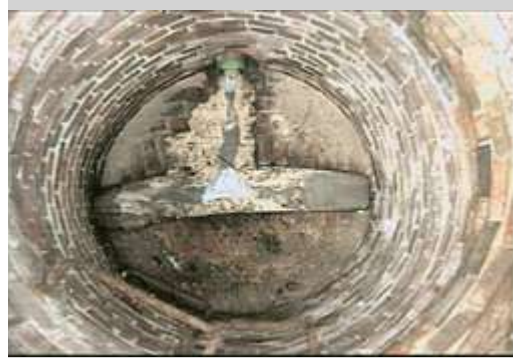
Defect 1

Condition: ☐ Sound ☐ Cracked ☐ Root Intrusion ☐ Deteriorated ☐ Leaks ☒ **Debris**

Count: **3** Missing: **0** ☒ **Corroded**

corroded steps, channel debris

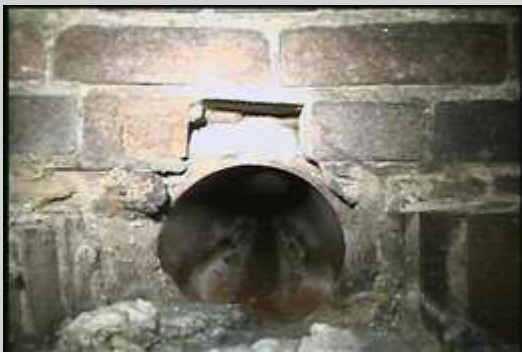
12 O'Clock Outflow

8 in. Circular Gravity Sewer
Pipe Out @ 12 O'Clock

Deposits: ☐ None ☐ Mud ☒ **Sludge** ☐ Debris ☐ Grease

Silt Depth: 3 (in.) Deposits Extent: **Medium**

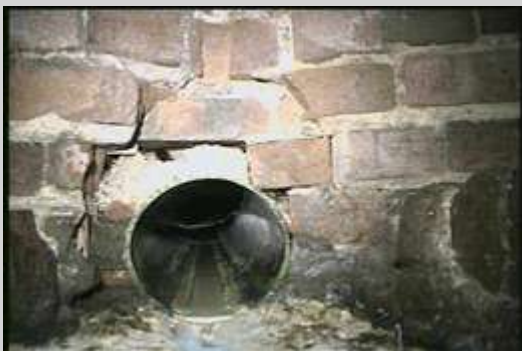
3 O'Clock Inflow

4 in. Circular Gravity Sewer
Pipe In @ 3 O'Clock

Deposits: ☐ None ☐ Mud ☒ **Sludge** ☐ Debris ☐ Grease

Silt Depth: 1 (in.) Deposits Extent: **Light**

Connects To: **Stub connection / abandoned**

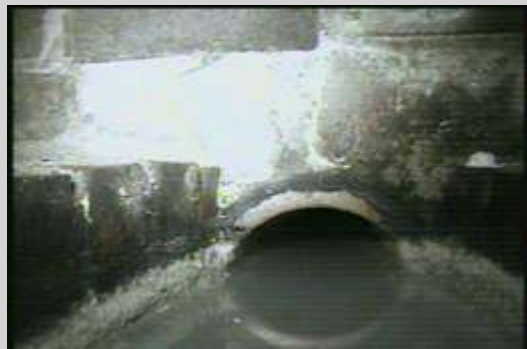
6 O'Clock Inflow

8 in. Circular Gravity Sewer
Pipe In @ 6 O'Clock

Deposits: ☐ None ☐ Mud ☒ **Sludge** ☒ **Debris** ☐ Grease

Silt Depth: **4** (in.) Deposits Extent: **Medium**
